# the magazine of the EUROCONTROL GUILD of AIR TRAFFIC SERVICES

Output	2
Safety of Air Navigation in Europe	2
The Central Data Bank (CDB), an Impression - by Bob van der Flier	6
Accident Report DC9 Inex Adria Ajaccio 1st Decem- ber, 1981	9
Instilux-2 Simulator - by Jerry Watson	14
An Aircraft Encounter with a Tornado	23
Collision at Sea - by Rob Bootsma	30
The FAA Air Traffic Control Systems "Command Centre" at Washington - by Patrice Behier	36
Artificial Stars	38

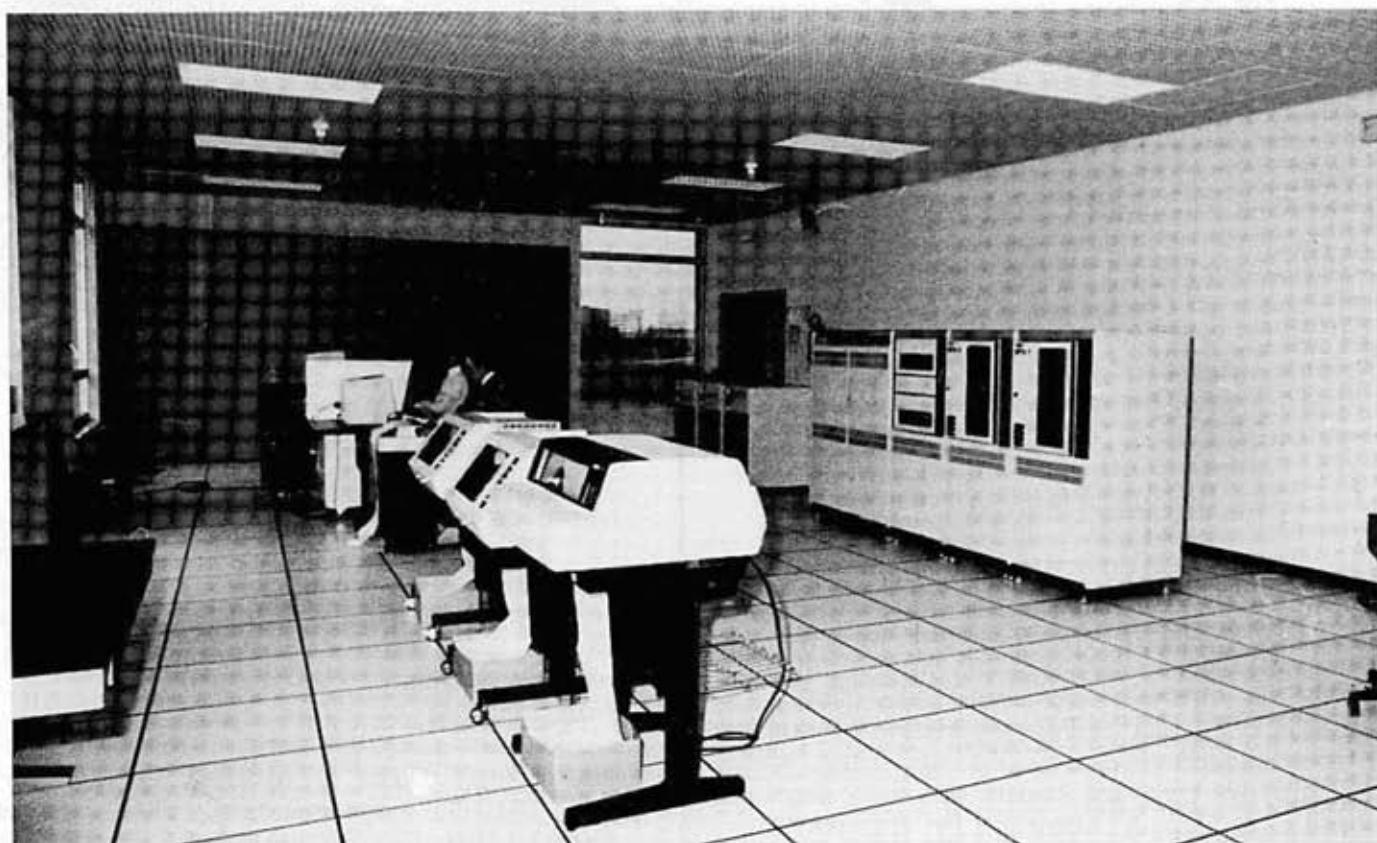
*The Instilux-2 computer centre.*

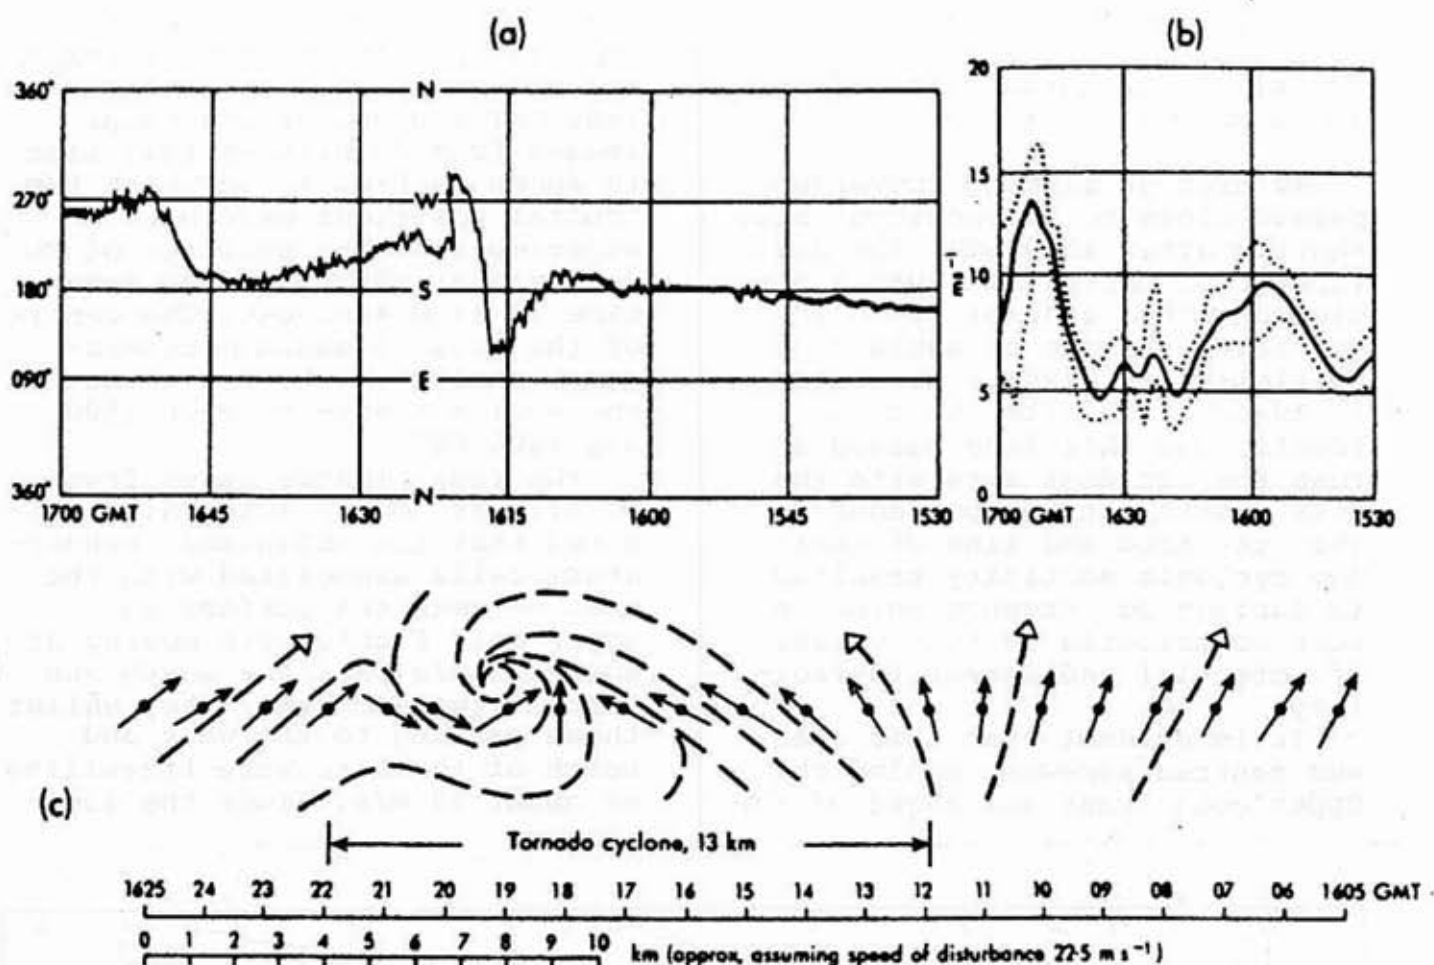
Figure 4. Anemogram traces (a), (b) from air pollution monitoring station at Moerdijk on 6 October 1981 and the deduced airflow (c) in the vicinity. The site of the anemometer is at point B in Fig. 2.

The only relevant autographic records near the observed tornado track or the scene of the accident were from an anemograph situated at an air pollution monitoring station at point B in Fig. 2. A reproduction of the records of surface wind direction and speed is shown in Figs. 5(a) and (b).

The record shows increasing wind speeds between 1535 and 1545 GMT with a gradual veer of surface wind from east of south to a little west of south, probably due to the downward transfer of momentum from the increasing south-westerly winds above the surface as the upper cold front passed. A second increase in wind speed occurred between 1640 and 1650 GMT and the wind veered to a westerly at 1650 GMT as the surface cold front passed. Between these two events lighter surface winds of about 4–7 m/s obtained and marked directional changes took place. These directional changes are analysed in Fig. 5(c) and sketched streamlines suggest that a tornado cyclone passed the station between 1612 and 1622 GMT disturbing the generally south-

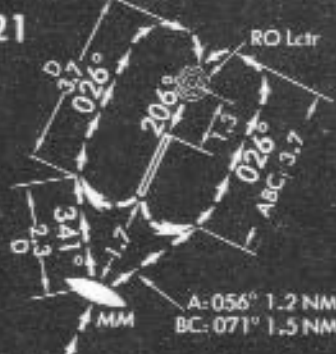
Rwy 21

- ① Landing not authorized except during DAY in VMC.
- ② Take-off not authorized except during DAY in VMC.
- ③ Right hand circuit rwy 10.
